CHISANA

HISTORIC STRUCTURE REPORT

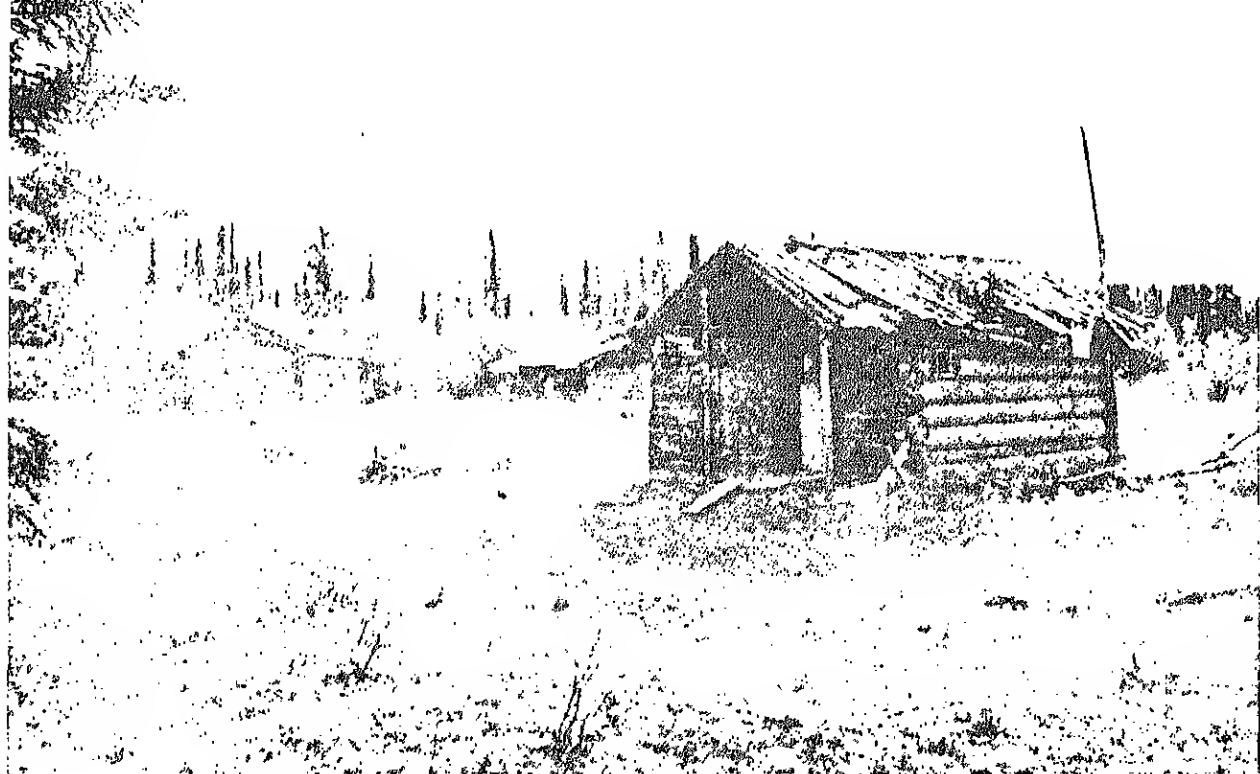
Photograph 1
Women's Jail, Chisana
Northeast Oblique.

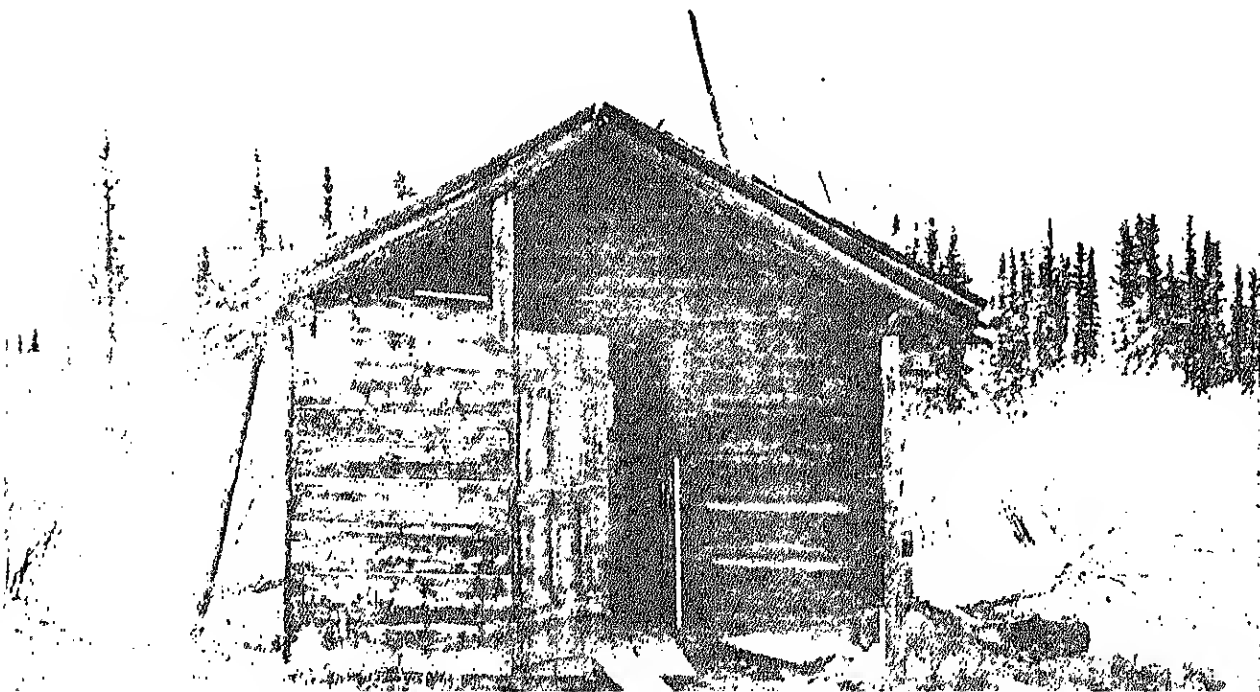
Photograph 2
Women's Jail, Chisana
East Elevation.

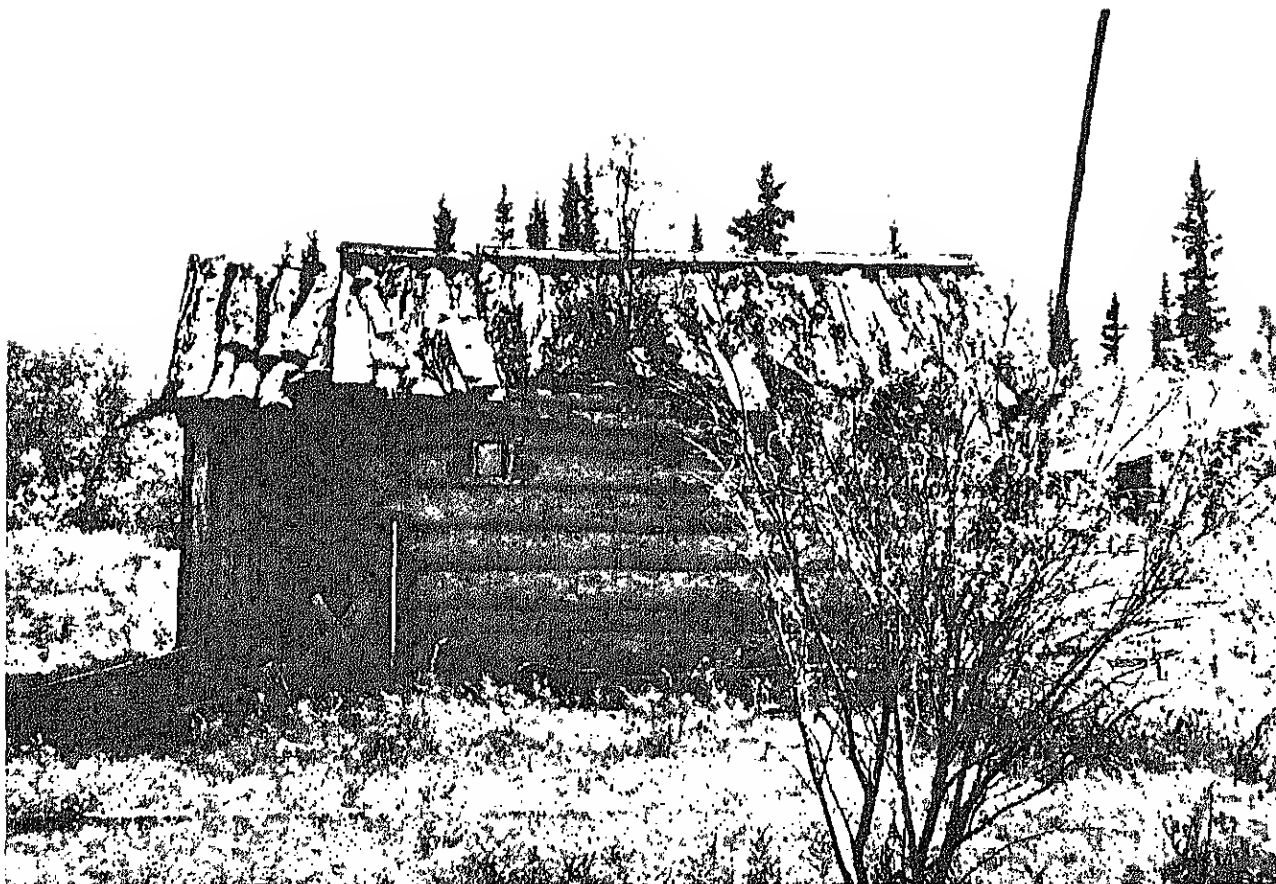
Photograph 5
Women's Jail, Chisana
North Elevation.

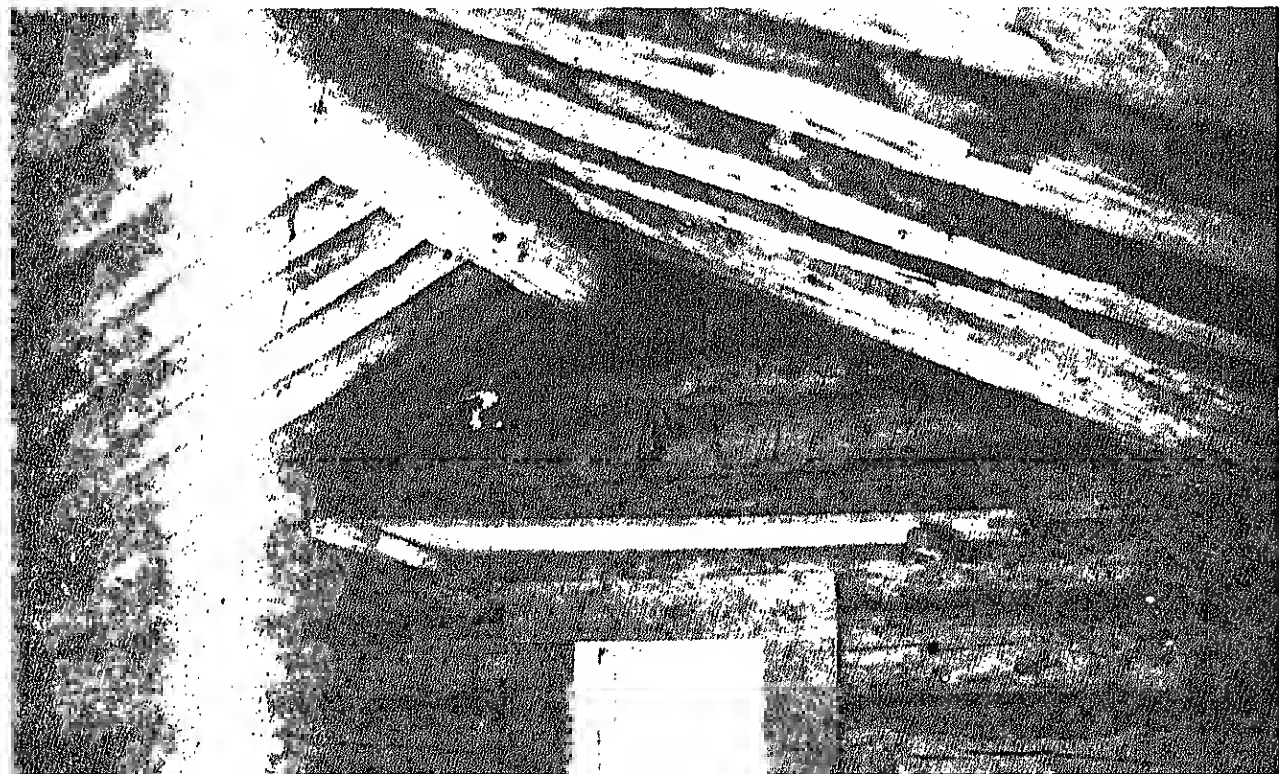
Photograph 9
Women's Jail, Chisana
Exterior; Window on north wall.

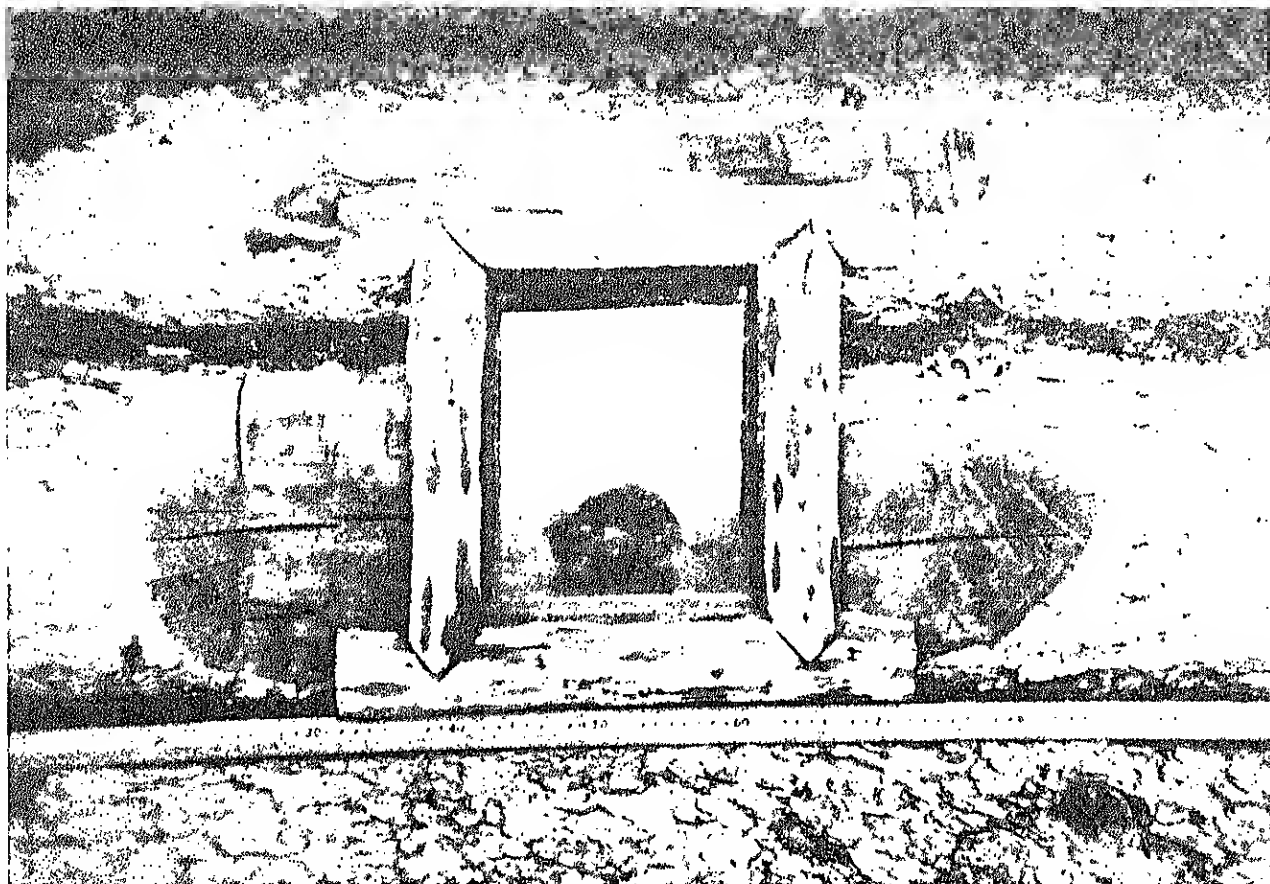
Photograph 10
Women's Jail, Chisana
Interior; Window on north wall.

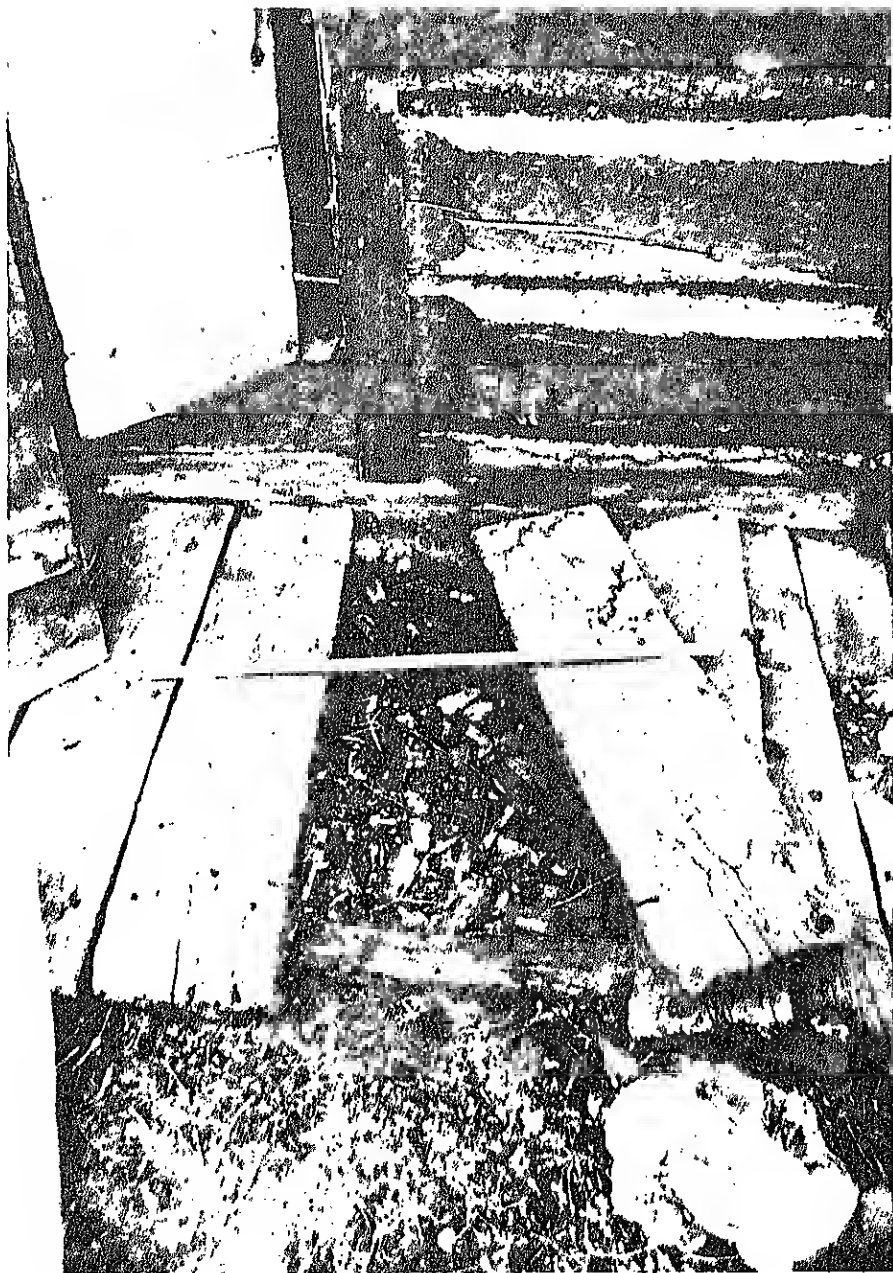
e sill logs on all sides of the building are in the final stages of decay. Soft and yielding to the touch, they show signs of dry rot and there may be carpenter ant activity. The sill logs are set directly on the ground with no evidence of any sub-foundation or rock piling. There may have been a garden along the south side at one time but everything has decomposed - including part of the foundation along the wall.

Photograph 14
Women's Jail, Chisana
Corner bracing at sill logs.

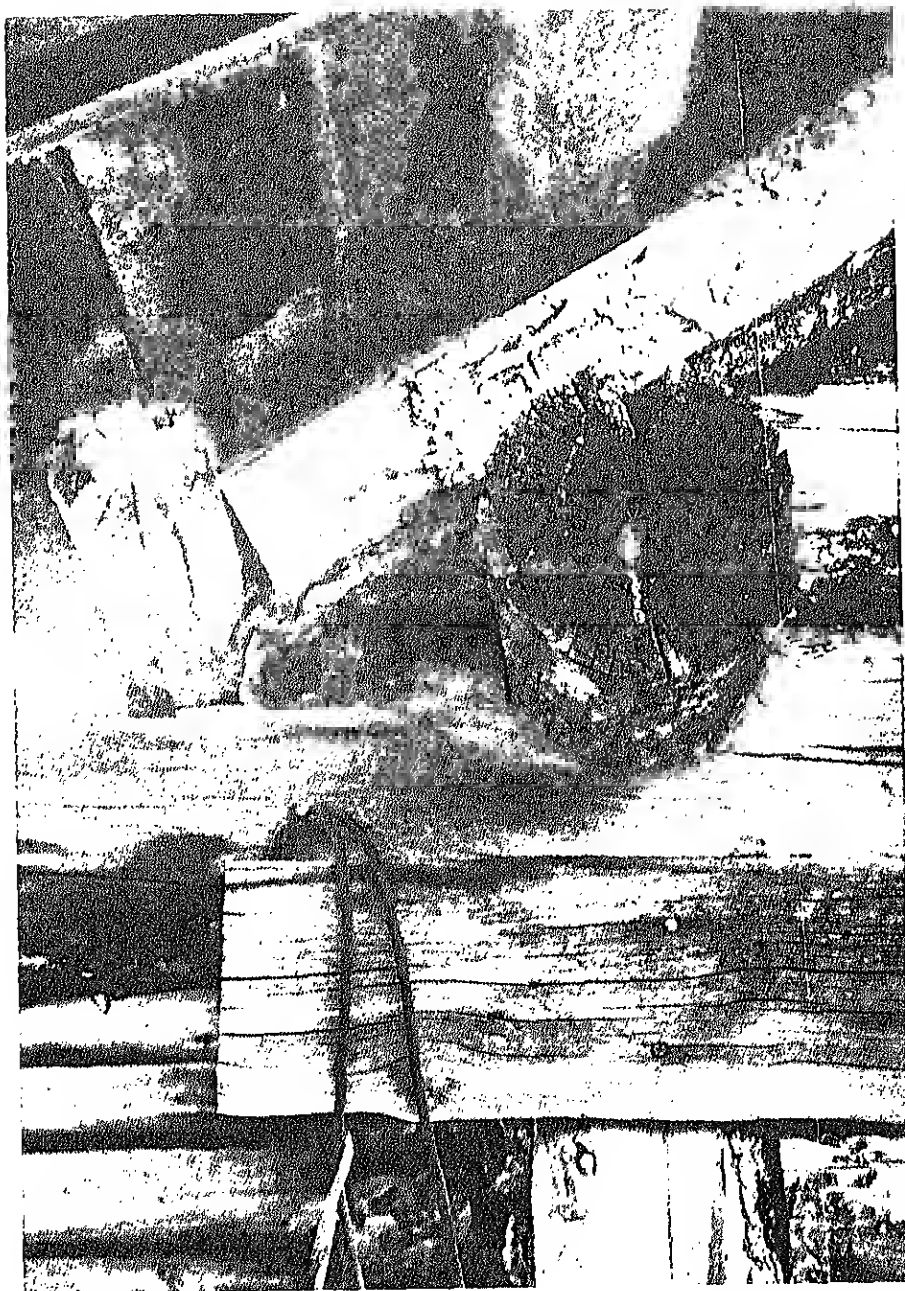
Photograph 19
U.S. Commissioner's Court, Chisana
Junction of the ceiling timbers,
butting pole, eave log and
plate log w/newer roof above
ceiling members

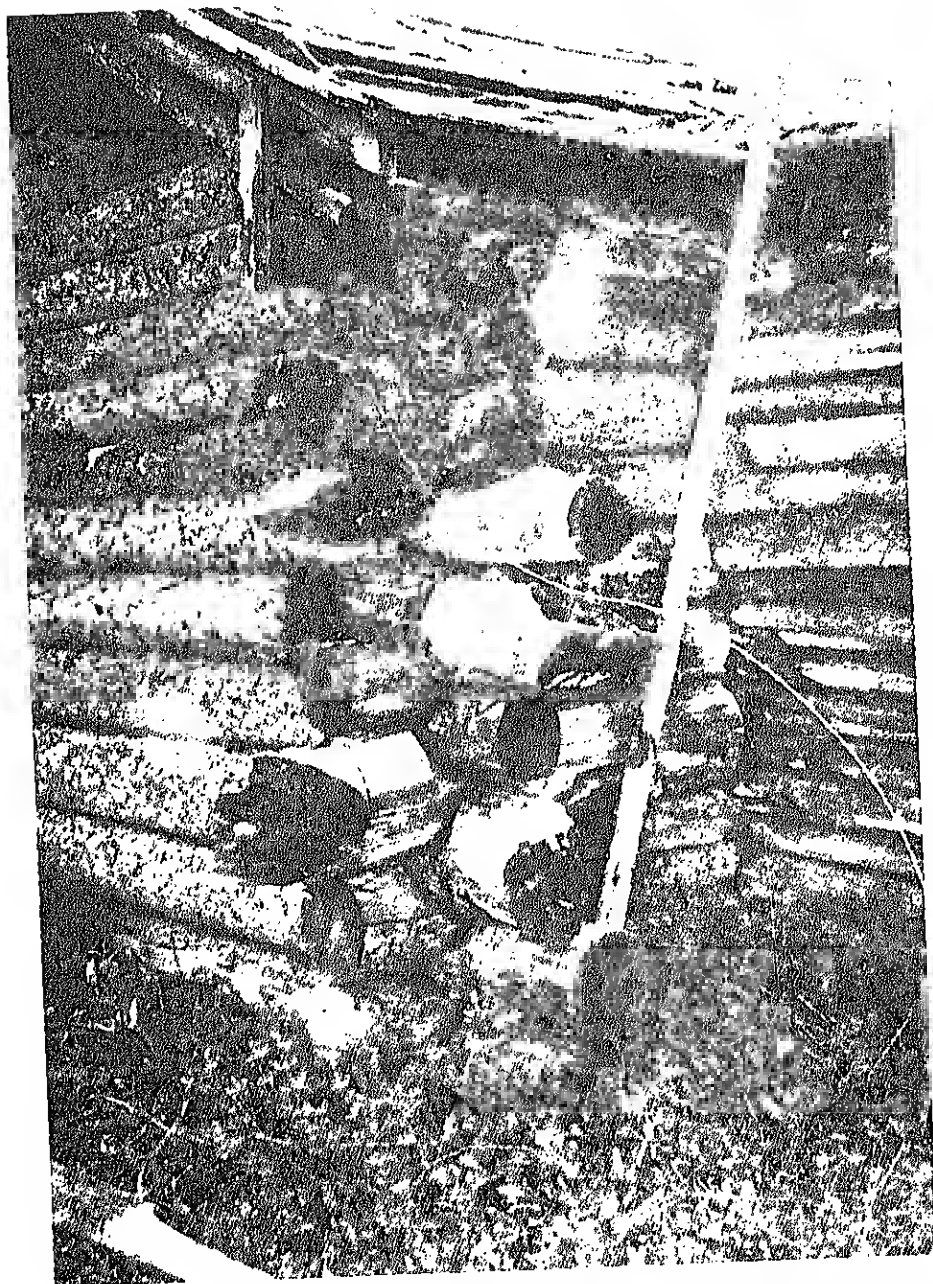
Photograph 20
U.S. Commissioner's Court, Chisana
V-notched log corner; showing
junction of addition logs and
newer roof.

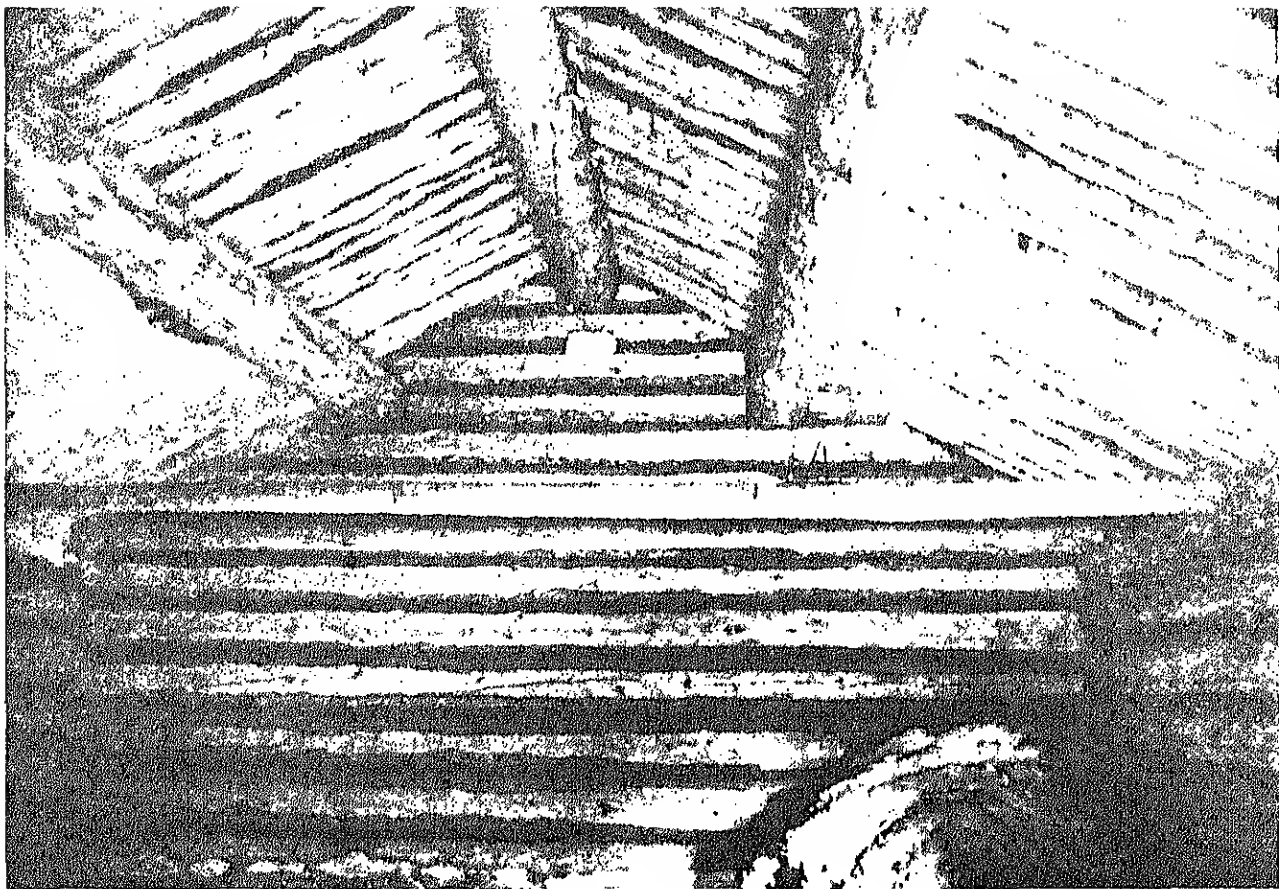
Photograph 21
U.S. Commissioner's Court, Chisana
Ceiling & North wall, showing split-
log ceiling members and peeled
purlines & ridge beam.

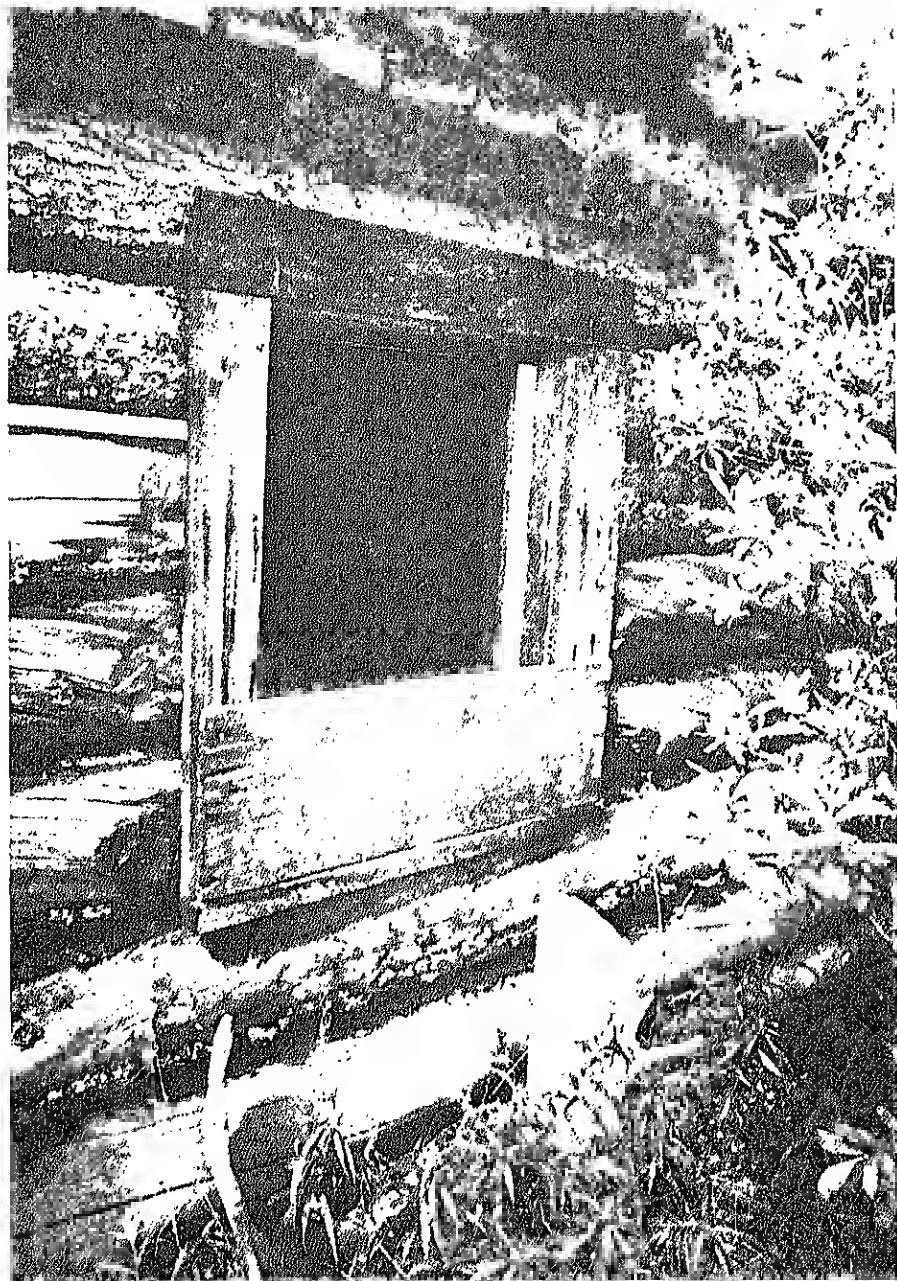
Photograph 22

The window on the east side is intact with the glass missing. The frame was built around a manufactured sash. The sash is held in place with wood stops. Logs on outside hewn flat on both sides of the window to allow trim to lay flat. Trim made from 1 inch x 4 inch rough sawn boards.

U.S. Commissioner's Court, Chisana
Window in East wall - logs hewn to
receive flat trim pieces.

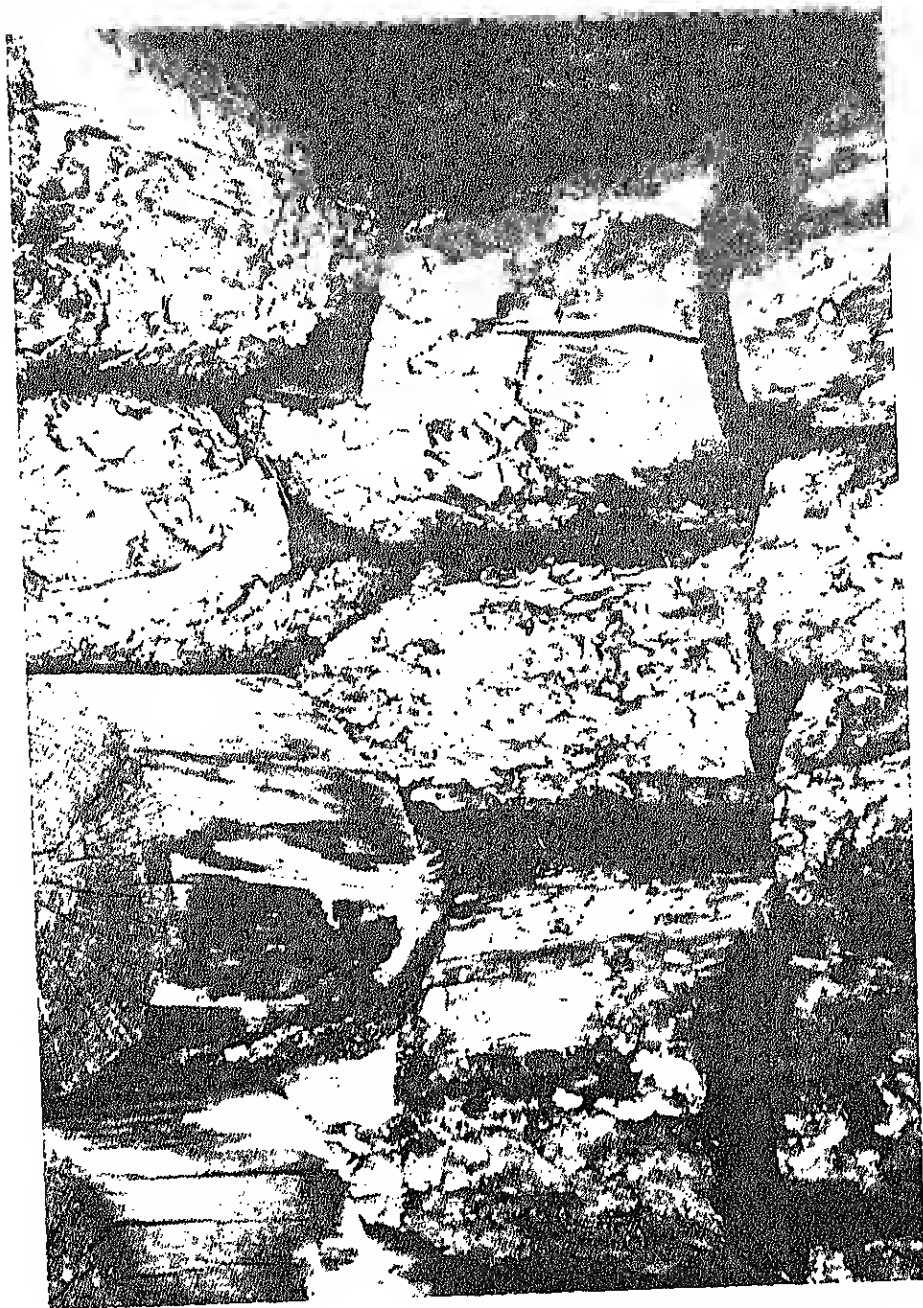
Photograph 24
U.S. Commissioner's Court, Chisana
Junction of main cabin logs and
porch logs (spline just visible
between second and third porch logs
on right)

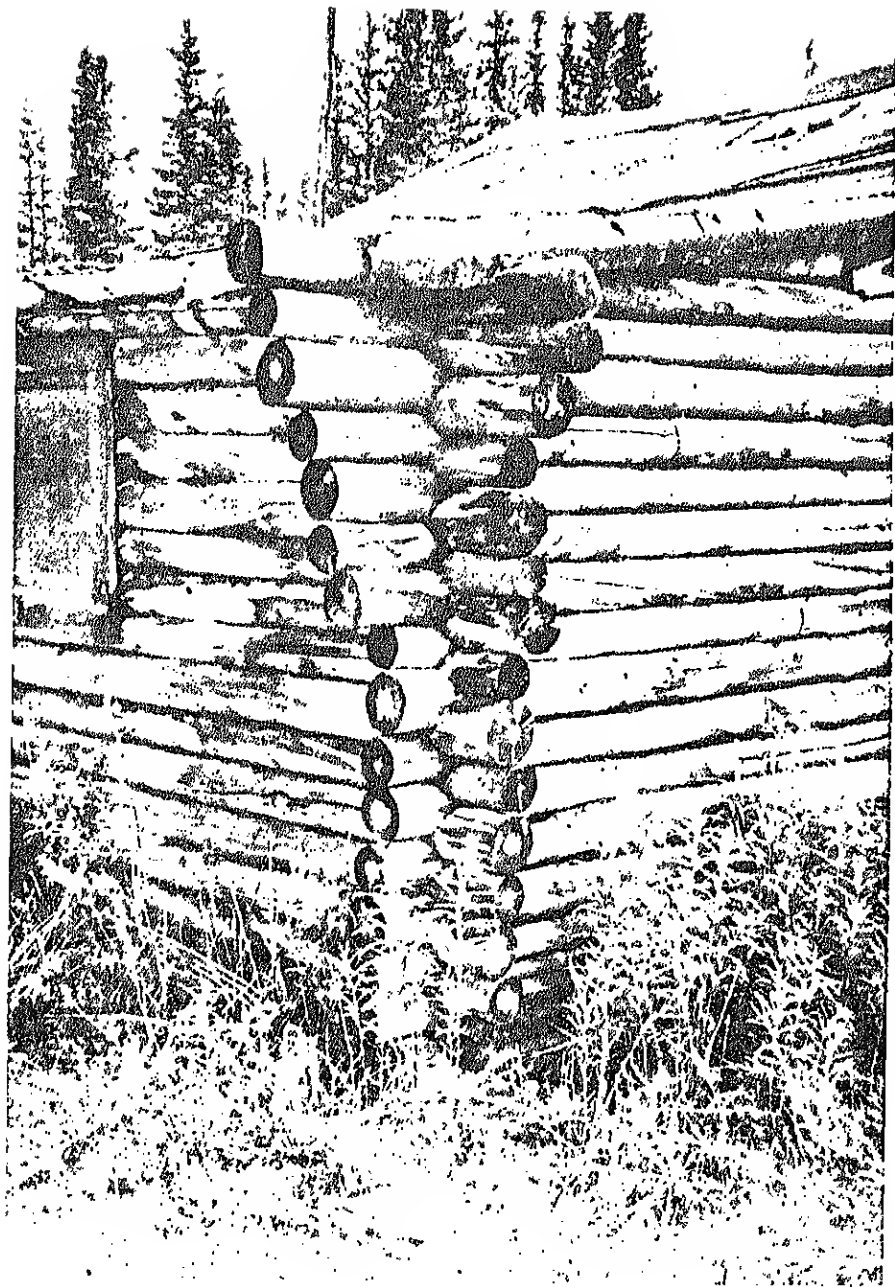
Photograph 27
U.S. Commissioner's Court, Chisana
Southwest corner of addition

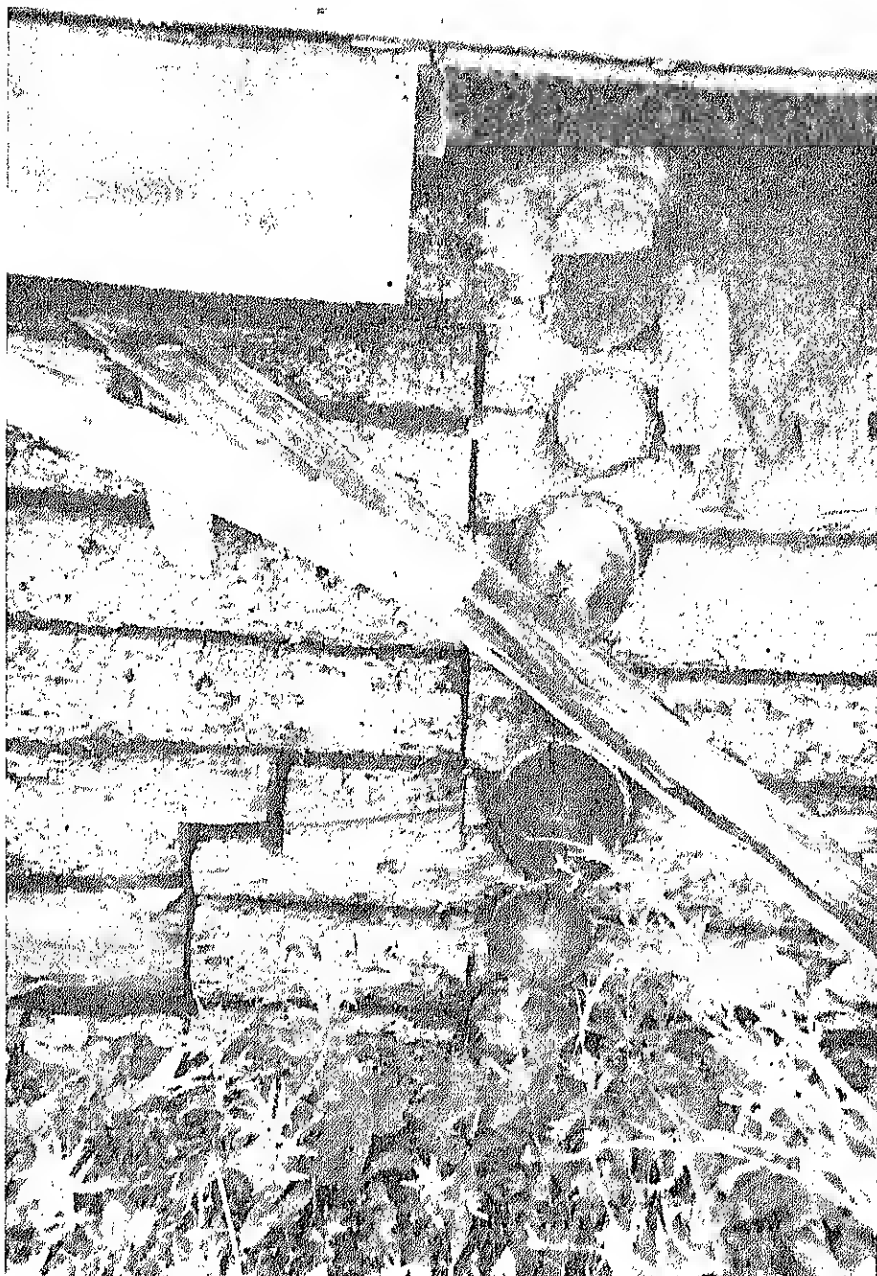
Photograph 40
U.S. Commissioner's residence, Chisana
Junction of main cabin logs (right)
and porch logs.

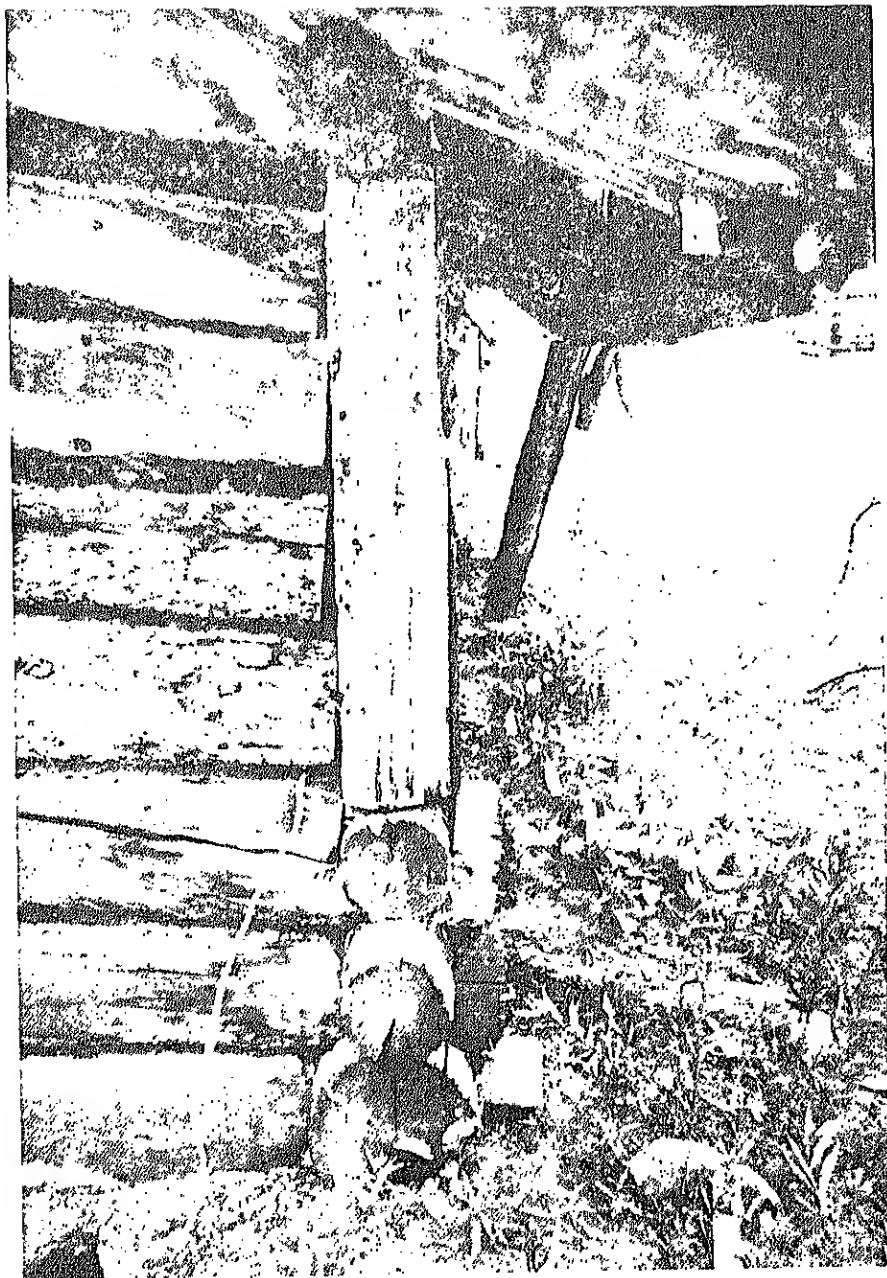
Photograph 41

Hudson Bay post at southeast corner of porch

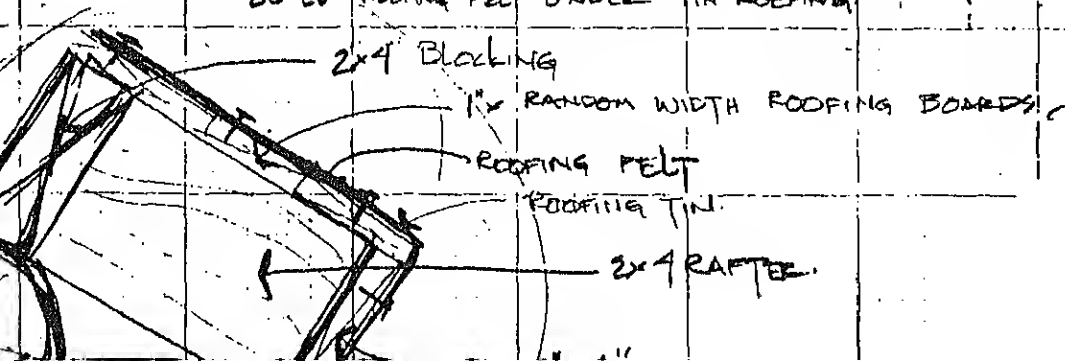
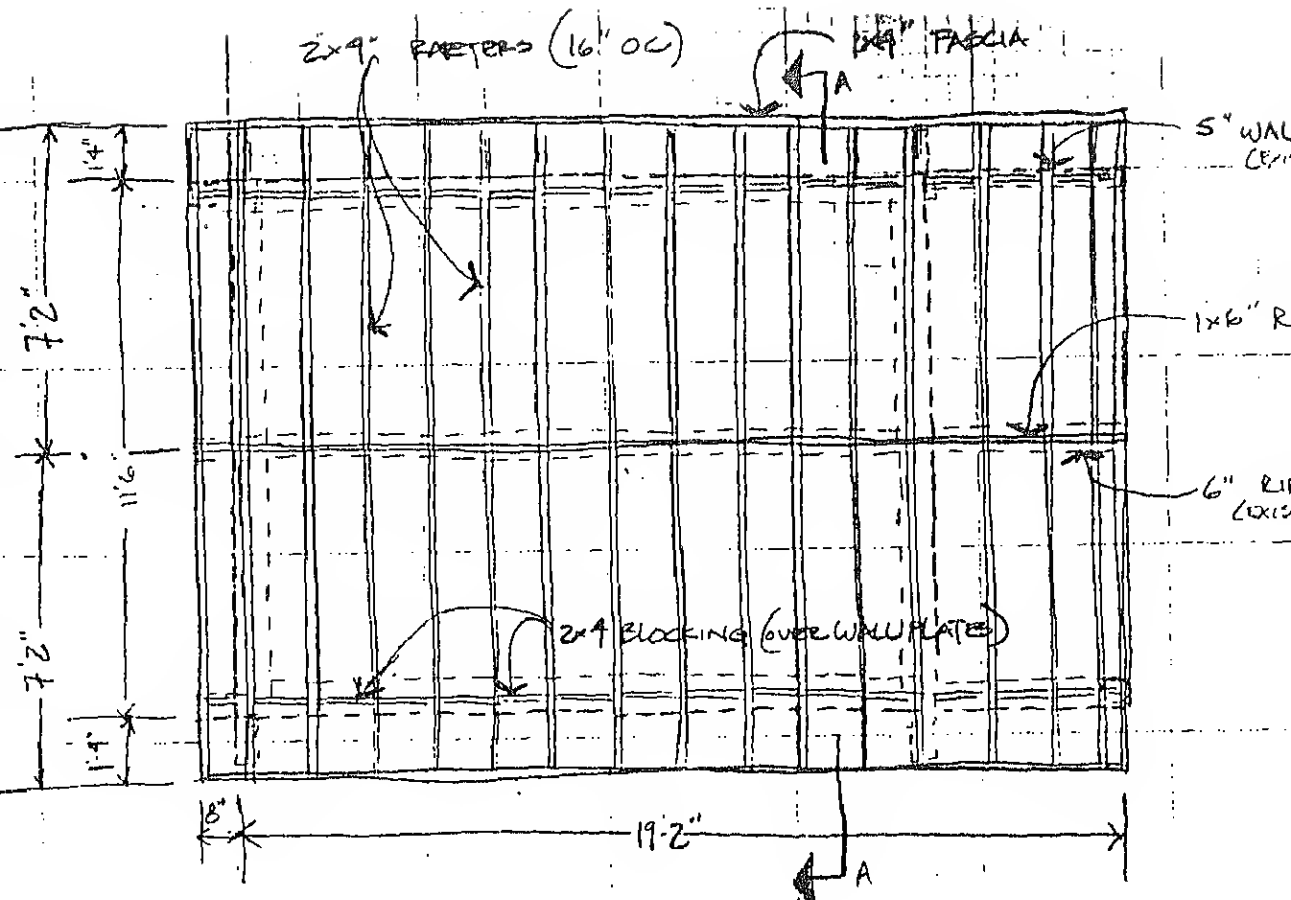
ROOF PLAN

CONDITION:

GAD - CONSIDERABLE ROT & DECAY

ROOFING SLATS DETERIORATED & MISSING IN PLACES

LARGE HOLE (4' x 6') ON SOUTH SIDE - CAUSED BY COLLAPSE OF A CEILING MEMBER.

RIDGE BEAM & WALL PLATES IN GOOD CONDITION

PORCH CEILING DETERIORATED.

3-16d NAILS @ EACH RAFTER.

80 LB ROOFING FELT UNDER TIN ROOFING.

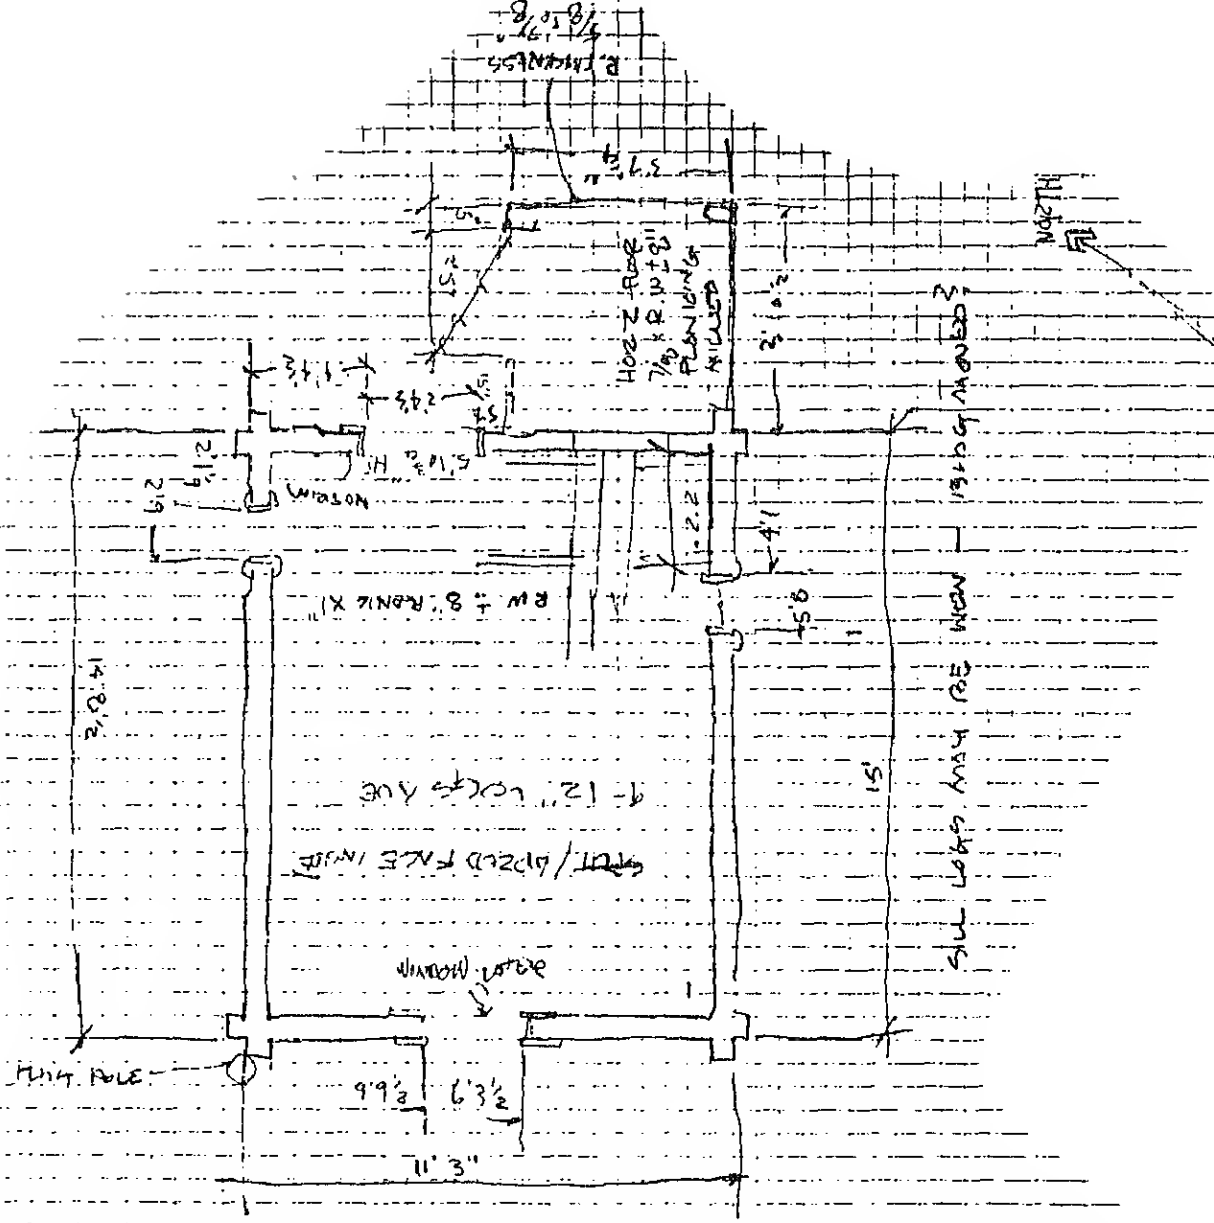
I. CONDITION:

GOOD - SOUND LOGS ADEQUATE ENDS
PORCH ADDITION LOOSE BOARDS IN ADEQUATE BACKING
ROOF SUPPORT @ SOUTHEAST CORNER ADEQUATE
WINDOW CASING & TRIM GOOD (SEE "WINDOWS & DOOR")

III. CONDITIONS:

GOOD - SOUND LOGS w/ GAPS BETWEEN SOME LOGS.
SUNDER FOR WALL PLATE @ FRONT OF PORCH LOOSE
WINDOW TRIM & CASING GOOD. GLAZING INTAC

IV. PORCH CONDITION

CABIN WALL GOOD w/ SMALL GAPS BETWEEN LOGS.
Porch FRAME & TRIM GOOD
PORCH ADDITION WALL OK. ROOF OVER PORCH ADDITION LOOSE: CASINGS ON
PORCH ADDITION ROOF SHOWING AGE.
DOOR TO STORAGE WON'T SHUT BECAUSE OF SETTLING OF PORCH.

RE-CHINK ANY GAPS BETWEEN LOGS w/ MOSS
NAIL 2"x4" STUD AGAINST LOG WALL BEHIND PORCH STORAGE ROOM WALL - REIN
BOARDS TO THE NEW STUD w/ 12d Galvanized Nails
REPLACE 1/2" x 1/2" PATTERNS ON BACK SIDE OF BOARDS (7 TOTAL ON SOUTH
WALL OF STORAGE ROOM)

RECHINK ANY GAPS BETWEEN LOGS w/ MOSS
REPLACE PORCH POST w/ NEW 5" PEELED WHITE SPRUCE LOG (PUT NOTCH IN
TO ACCEPT WALL PLATE - THE JOE NAIL IN w/ 12d galvanized nails)

RECHINK ANY GAPS w/ MOSS
REMOVE CASINGS FROM TOP OF STORAGE ROOM & REPLACE w/ ROOFING FELT.
REMOVE POST @ NORTH EAST CORNER OF STORAGE & REPLACE w/ LONGER 2"x4" ST
ATTACHED TO RAFTER (ALTER POST 1/2" UP.)

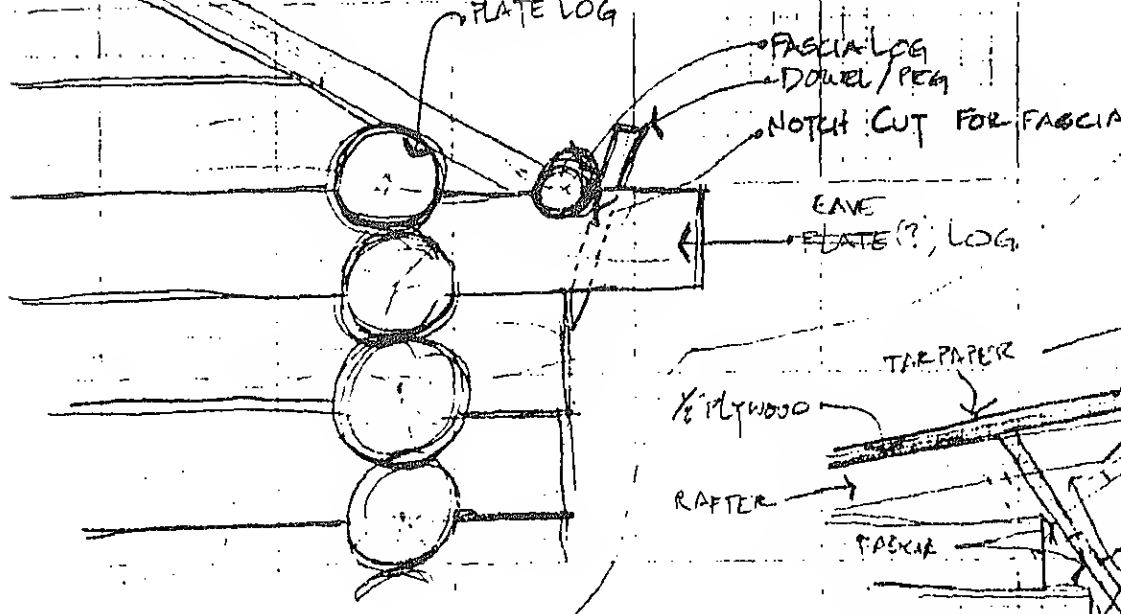
#1 DETAIL - GABLE END FASCIA

CONDITION:

ROOF - SOD ROOF SETTING TOPS OF CEILING MEMBERS. (9' x 4' to 6" HALF SPLIT
WHITE SPRUCE LOGS (AND SHUT SIDE, DOWN 4' 6" ON WEST SIDE.)
NEWER ROOF ON TOP W. FELT PAPER - FAIRLY GOOD SHAPE - NO SHEEDS GROWING
LIGHTLY ASYMMETRICAL W. RIDGE SHIFTED TO EAST. (In front - Symmetrical
STRUCTURAL MEMBERS - RIDGE FURLING & PLATE LOGS IN GOOD SHAPE
"PLATE" LOGS AT GABLE ENDS MISSING SUPPORT NOTCHES FOR FASCIA B
SIDE) SEE DETAIL BELOW LEFT (PAGE 12)
ROOF IN ADDITION - CHANGE IN SLOPE (TO 3:12 MAX FROM 6:12)
PLYWOOD DELAMINATING, SAGGING & WATER STAINED
RAFTERS EXPOSED TO MOISTURE - SIGNS OF DECAY - REST ON NEW LOG
@ TOP OF PITCH - SEE DETAIL #2 BELOW LEFT

REMOVE ALL ROOFING MEMBERS OF NEWER ROOF AND ADDITION ROOF
REMOVE SOD & CEILING MEMBERS OF MAIN CABIN
← SET NEW PLATE LOG SUPPORTS ON GABLE ENDS W/ NOTCHES FOR FASCIA
REPLACE CEILING MEMBERS W/ 4-6" SPLIT LOGS (W. SPRUCE) SET 3/4" IN
DOWN - 4" ON EAST SIDE - 4' 6" ON WEST
SET NEW 9" RAFTERS ~~ON~~ ON ADDITION - 16" OC
NAIL 1" x RANDOM WITH HEADS ACROSS ADDITION RAFTERS (15 PER DETAIL)
NAIL 18" METAL FLASHING AT JUNCTIONS
TAP PAPER OVER LOTIN ROOF
METAL SHEET ROOFING (SMALL SHEETS "DESIGNED TO PULL OR PARTIALLY RUST")
→ PLACE 4-5" FASCIA LOG ALONG ENDS OF CEILING MEMBERS - SETTING IN
"PLATE" LOGS - VOWEL/PLE INTO POSITION.

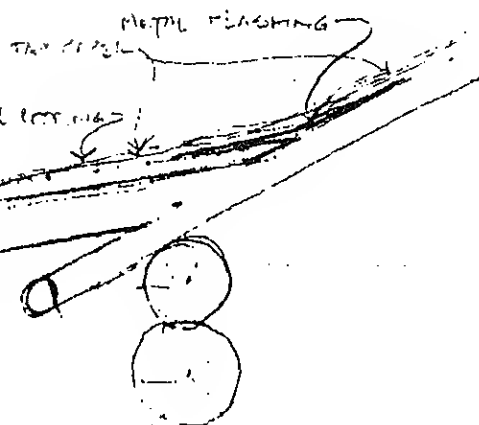
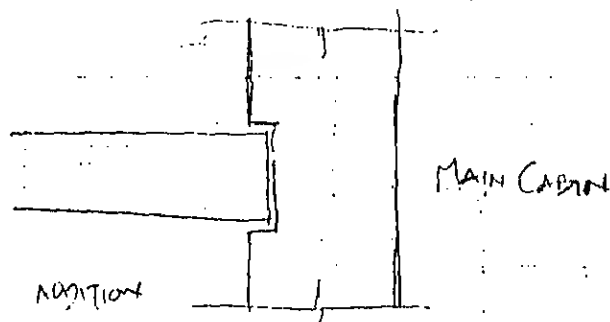
#3 DETAIL N.T.S.

SOOTIL CONDITION:

RAILED & LEARNING - MAJOR ENDS TO RIGHT OF PORCH DOOR.
SILL LOGS WEARING - PROBABLE CAUSE OF SETTLING
PLANK/BOARD COVERING GAP TO LEFT OF PORCH DOOR HEADER (THIN)
MAIN CABIN LOGS CUT IN FLAT TO TAKE FLAT TRIM (1 3/4" THICK) ON PORCH SIDE
NEWER FLAT INSIDE W/ 3/8" TRIM
BOTH SOUTH WALLS LEAN NORTH FROM PLATE LOGS UP.

TREATMENT:

REMOVE BOARDS FROM OUTER LEFT SIDE (INSIDE & OUTSIDE)
REMOVE TRIM BOARD OF HUDSON BAY SECTION ON RIGHT SIDE - RE-ATTACH PIND
HUDSON BAY CONNECTION AT ALL POINTS
SET ONE NEW NOTCHED LOG INTO EACH SIDE OF FRONT @ TOP WHEN PLAT
HAS BEEN REPLACED (5" DIA LOGS 3' 1/2")
NOTE: NAME BOARD & 3" FASCIA ON PORCH

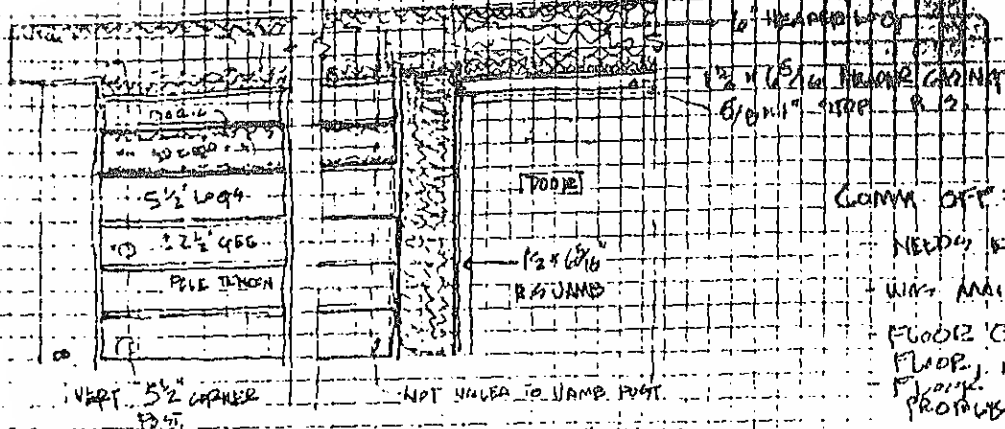
COMMON OFF =

NEEDS EMERGENCY ROOF
